THE CALIFORNIA EARTHQUAKE OF APRIL 18, 1906

STATE EARTHQUAKE INVESTIGATION COMMISSION

IN TWO VOLUMES AND ATLAS

ANDREW C. LAWSON, CHAIRMAN

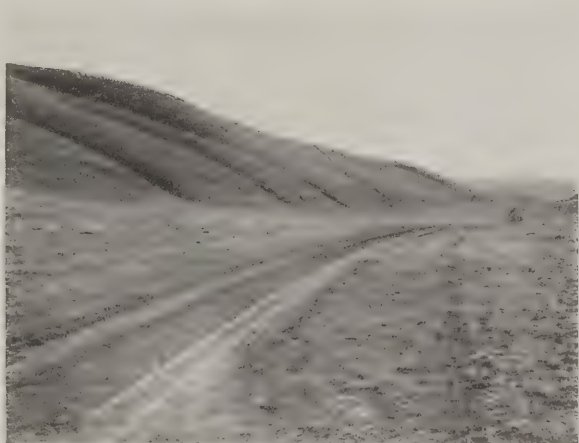
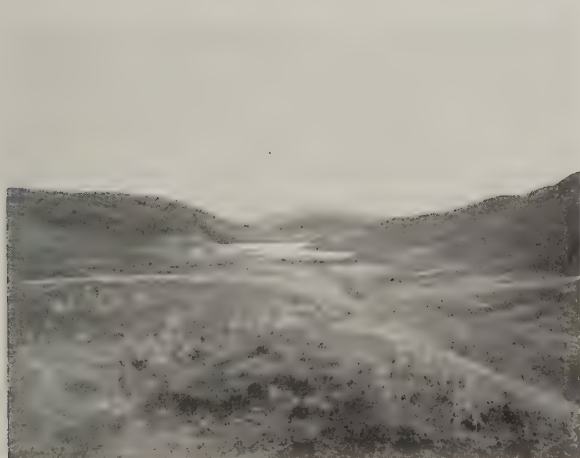
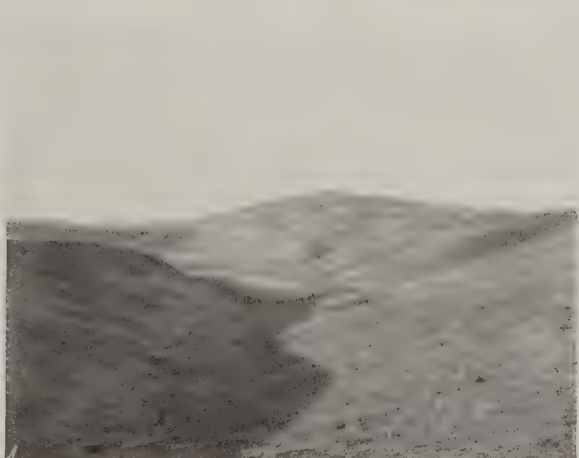
D. Rift, just beyond southeast end Carissa Plain. A. C. L., Jan., 1906.

E. Rift, just beyond southeast end Carissa Plain. A. C. L., Jan., 1906.

F. Rift, just beyond southeast end Carissa Plain. A. C. L., Jan., 1906.

A gentle divide separates the southern end of the Carissa Plain from a long narrow sink extending along the Rift line toward the southeast. (Plate 21D, E, F.) This sink includes an area 6 miles long and in places its drainage is fully 3 miles wide. Several depressed alkali flats, covered with water during the wet season, receive the scanty run-off of this dry region. These depressions are several hundred feet wide and are bordered upon opposite sides by quite sharp bluffs, in some places 100 feet high. The phenomena suggest the sinking of long narrow blocks between two walls. This reach of 6 miles between the ranches of Job and Emerson is one of the most interesting areas examined. The larger scarps belong to some ancient disturbance, while the last one, probably dating from 1857, is marked by features comparatively insignificant.

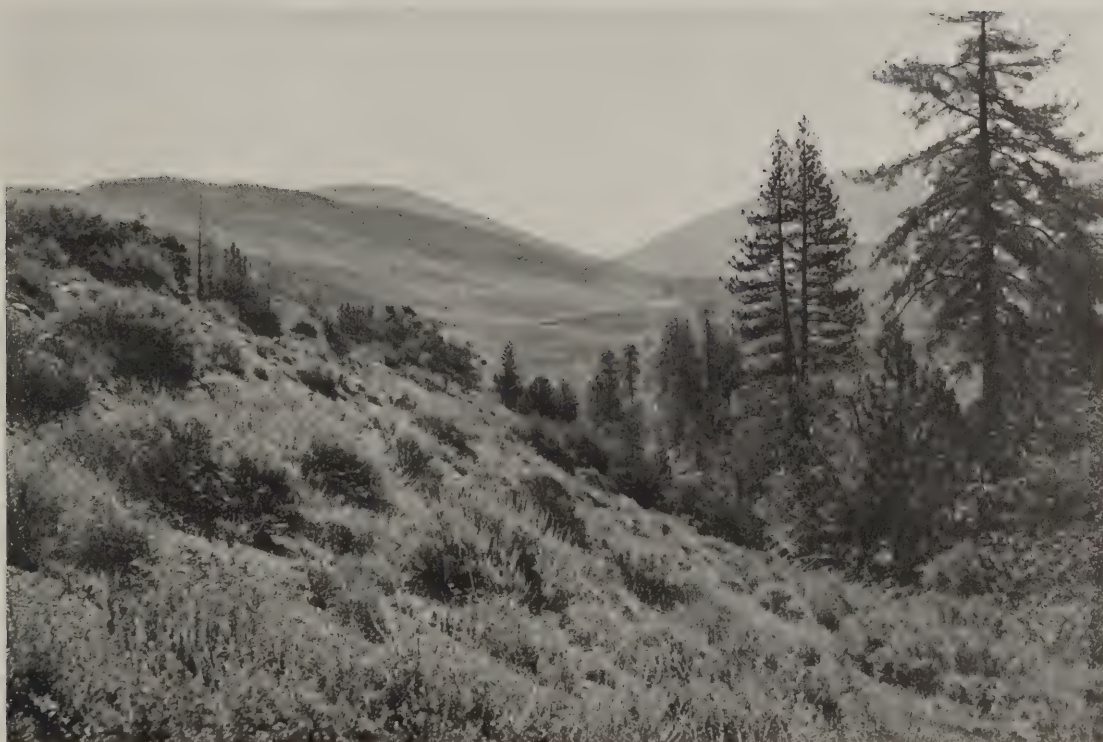
A. Looking south-southeast along the Rift toward Cuddy Valley from head of San Emedio Canyon. H. W. F.

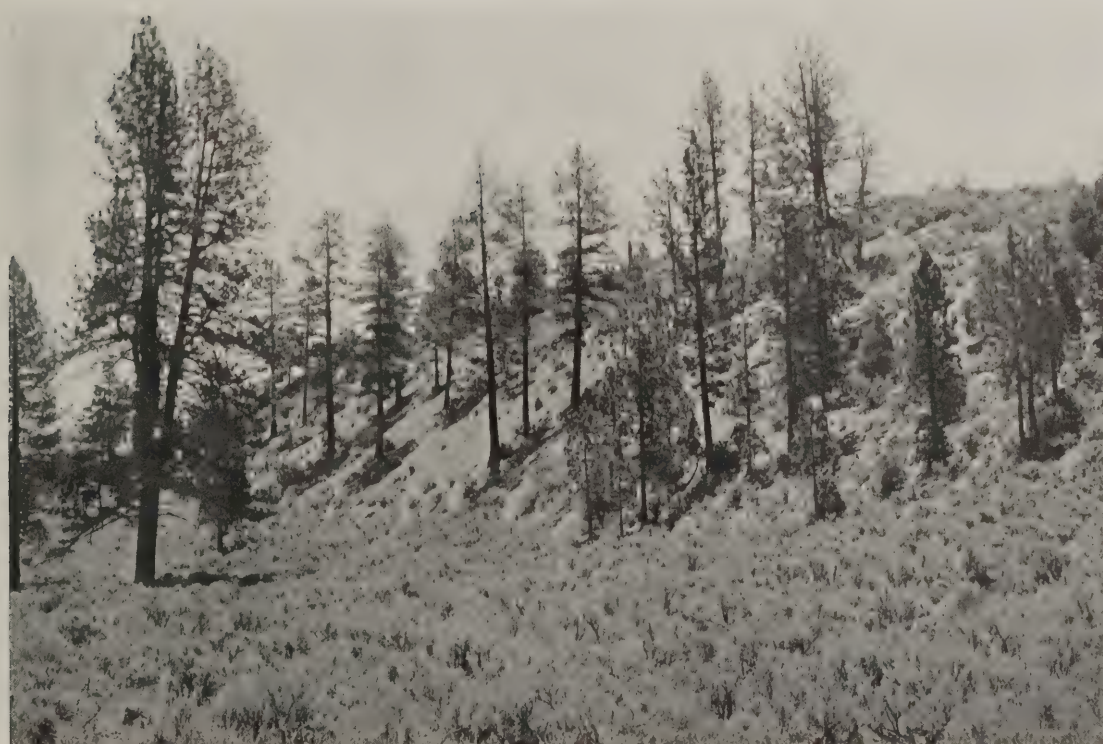
B. Old fault-scarp in Rift. East end of Cuddy Valley. H. W. F.

(See plate 22B.) The fissure follows its northern side for several miles and then, bending a little toward the south, crosses the canyon and takes a course for Tejon Pass. The granitic mountains upon the north of the canyon rise with exceedingly steep slopes, the rocks of which have been thoroly shattered. Immense quantities of rock débris have been brought down the gulches, building up in the main canyon a succession of large and steep débris fans. So much débris has been carried down the canyon that it has been blocked at the point where it turns toward old Fort Tejon, and has thus given rise to Castac Lake. The Rift crosses the divide at the gap known as Tejon Pass. Here there are features due to two movements. Descending a few hundred feet, we find ourselves in a long valley, extending about 10 miles in a direction a little south of east. Springs, marshes, and two ponds mark the line of the Rift from Gorman Station easterly. (Plates 23B and 24A.)

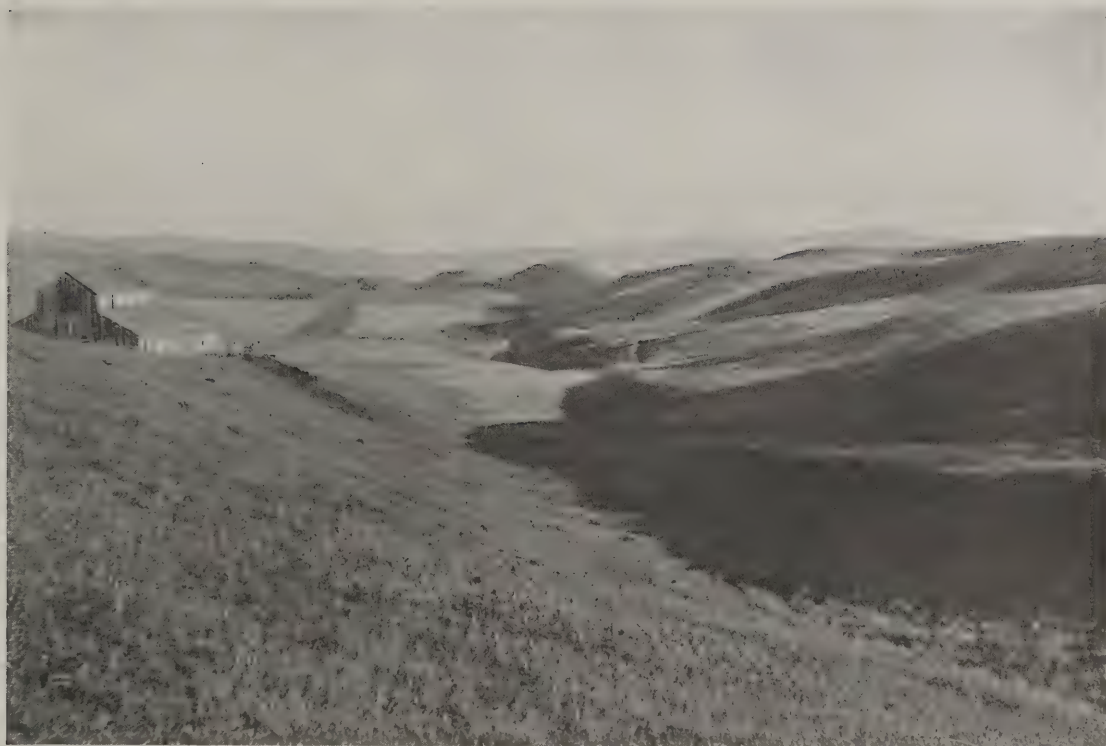
A. Looking northwest along the Rift from Emerson's place, near Pattiway. H. W. F.

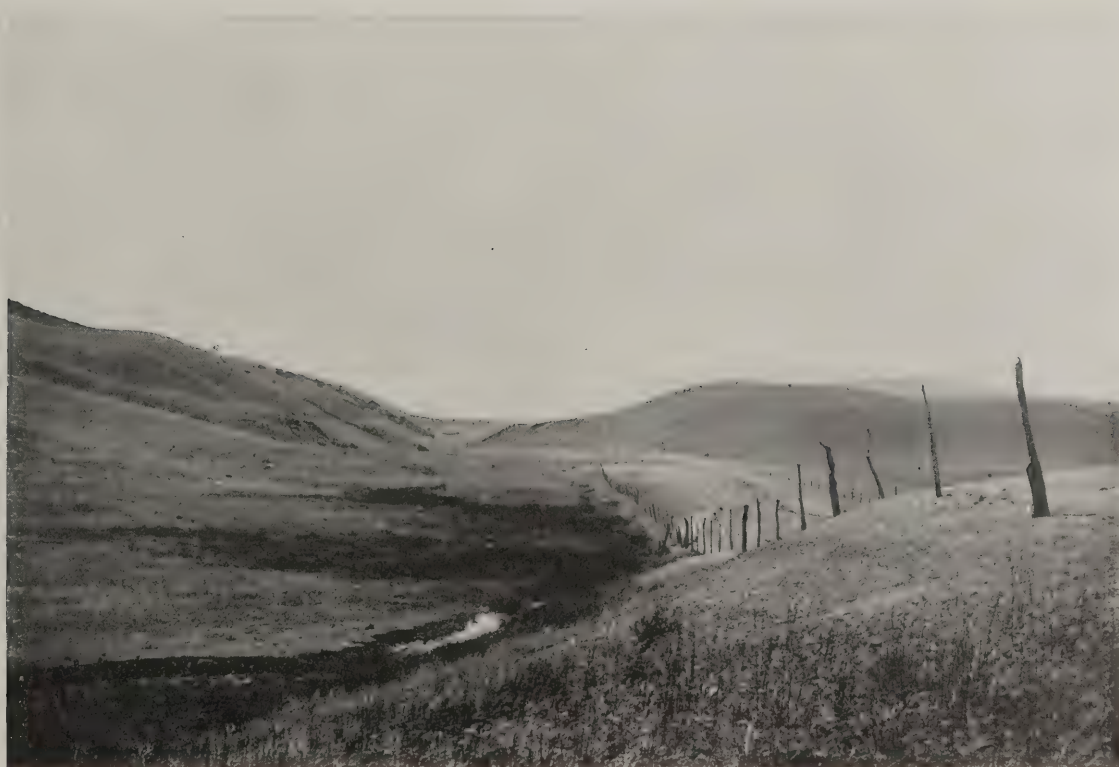
B. Looking east along the Rift from Gorman Station. The low scarp was probably made in 1857. H. W. F.

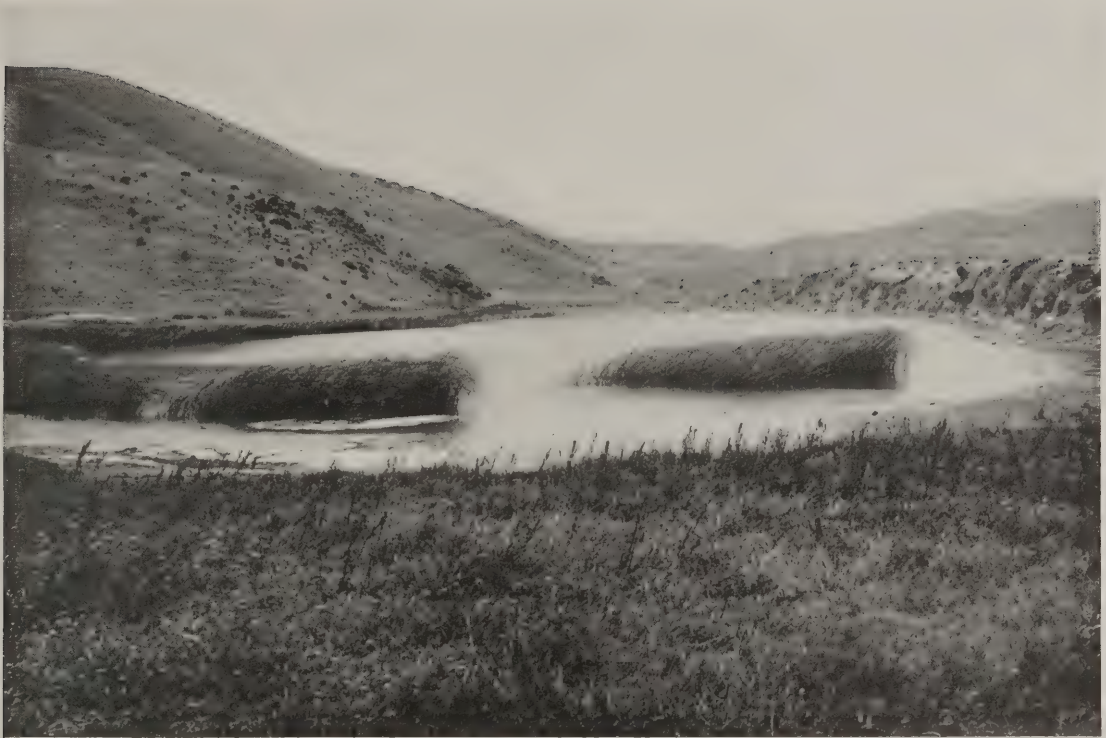
A. Pond and scarp in Rift east of Gorman Station. H. W. F.

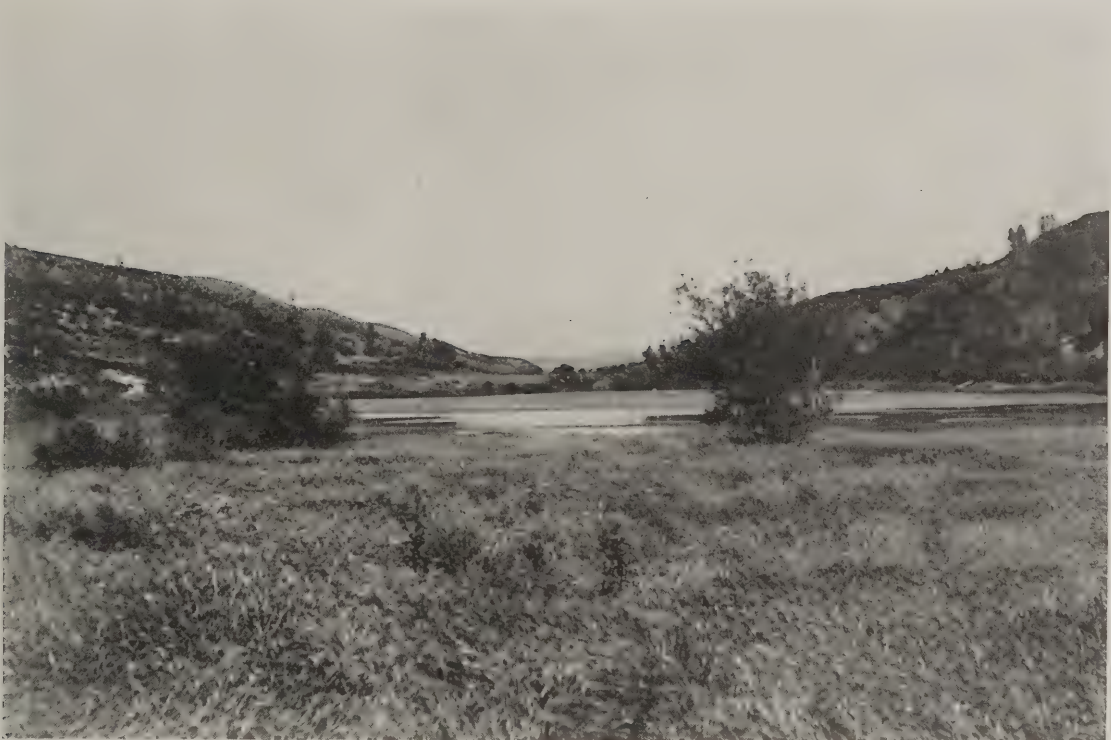
B. Lower Lake Elizabeth. In the Rift. H. W. F.

Lake Elizabeth and Lower Lake (plate 24B) are both due to the blocking of the drainage of two valleys extending along the Rift. These valleys lie on the slope of the range toward the desert (Antelope Valley), but their outlet is southward by a narrow canyon thru the heart of the mountains lying between the desert and Santa Clara River. A low escarpment along the southern side of the valley in which Lake Elizabeth lies, and eastward, is replaced by a lofty rounded ridge which appears to be due to some one of the movements along the old fault. For several miles east of the lake (plate 25A) the distinctive and characteristic features of the Rift are not as easily made out, altho the ridge just mentioned is full of springs and exhibits a widespread landslide topography. Toward the eastern end of this ridge small hollows and a low, indistinct escarpment again appear. The ridge separates Leones Valley, a fertile and well-watered district 5 or 6 miles long, from the open Mojave desert on the north.

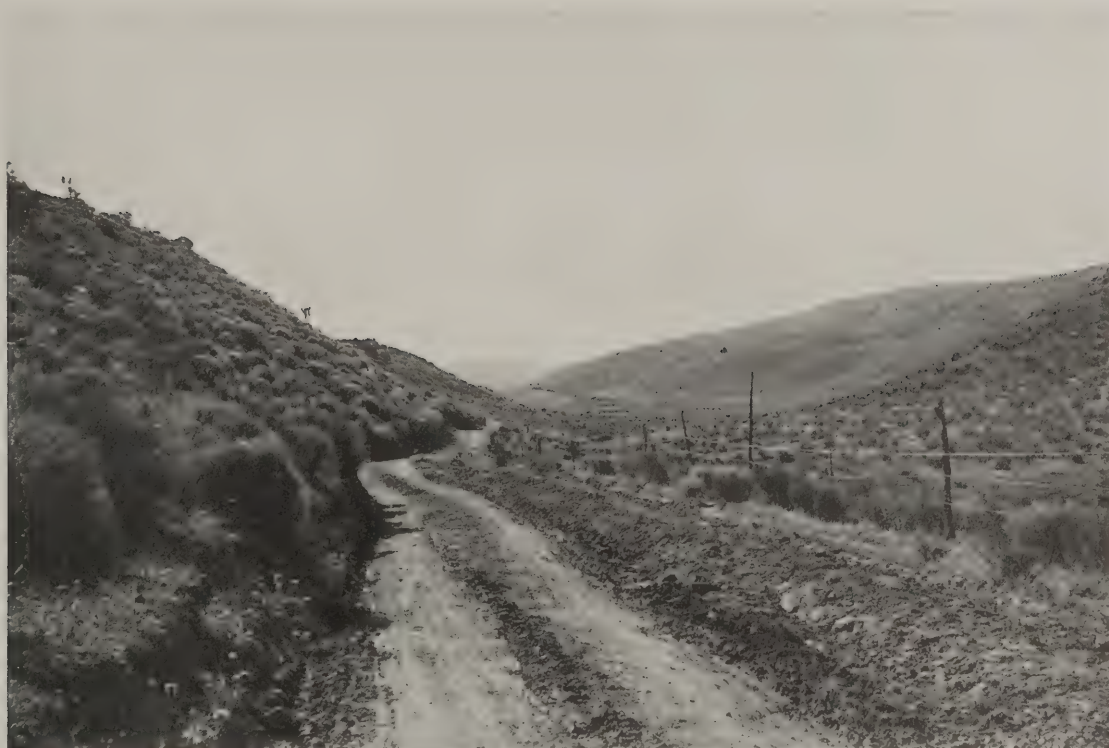
A. Looking southeast along the Rift between Lake Elizabeth and Palmdale. H. W. F.

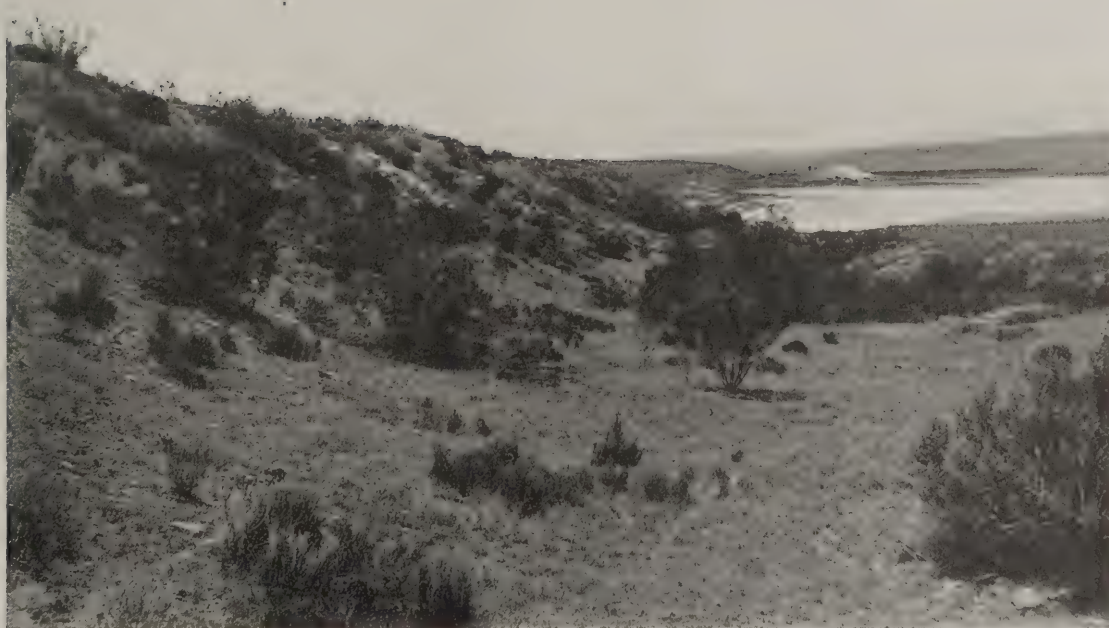
B. Looking east along the Rift scarp west of Palmdale. H. W. F.

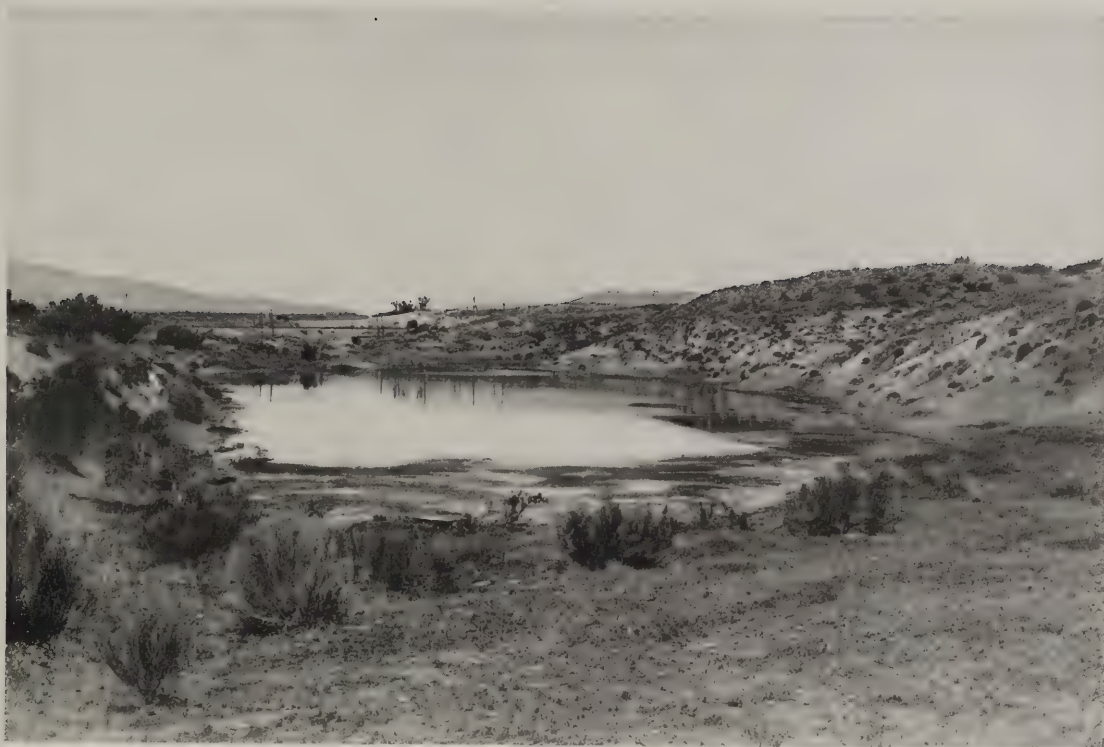
A. Sink between 2 scarps of the Rift a mile south of Palmdale. H. W. F.

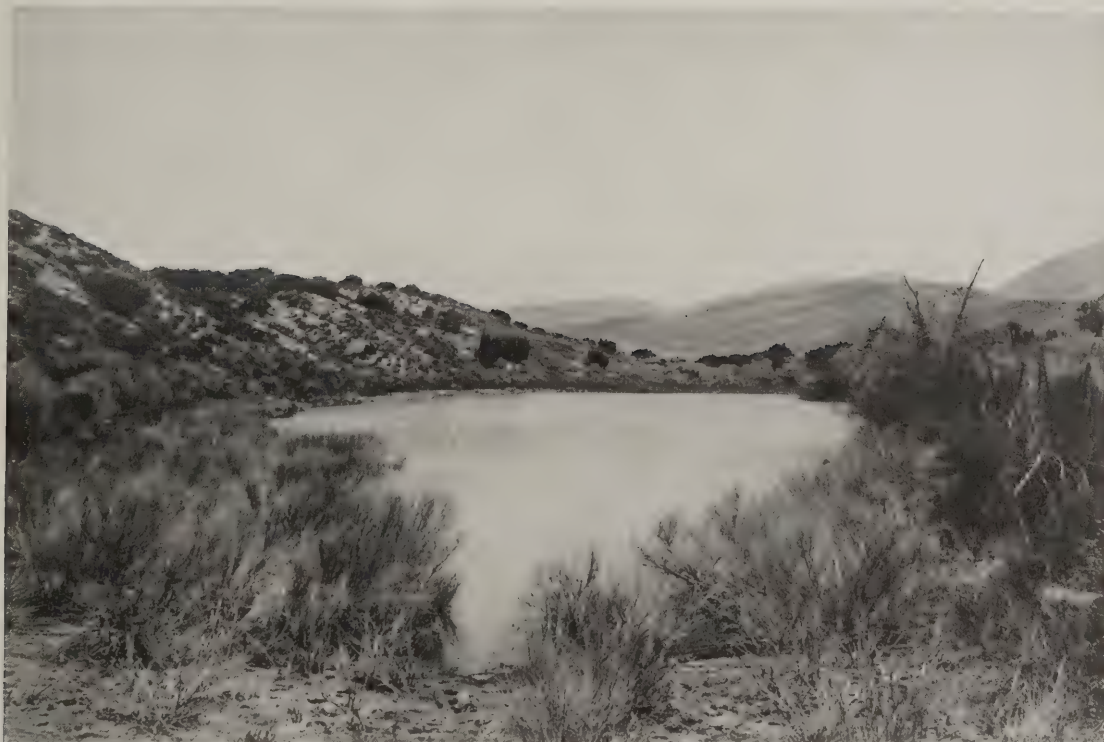
B. Pond in the Rift 2 miles west of Big Rock Creek, Mojave Desert. H. W. F.

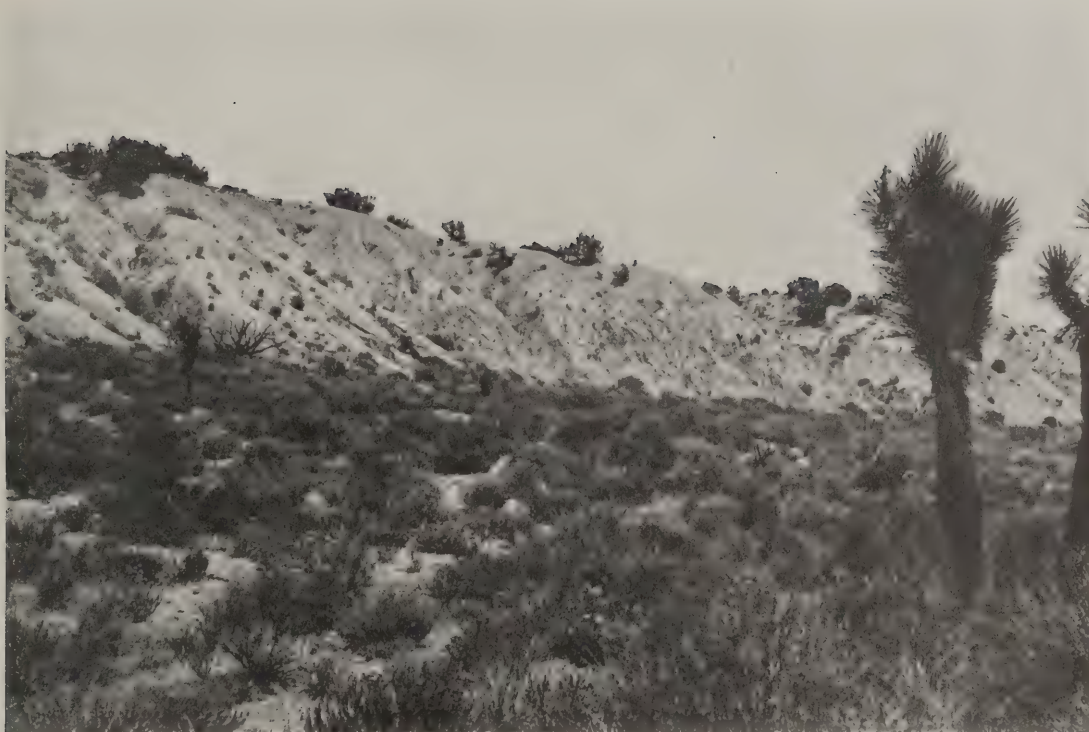
A. Fault-scarp in the Rift, Mojave Desert west of Big Rock Creek. H. W. F.

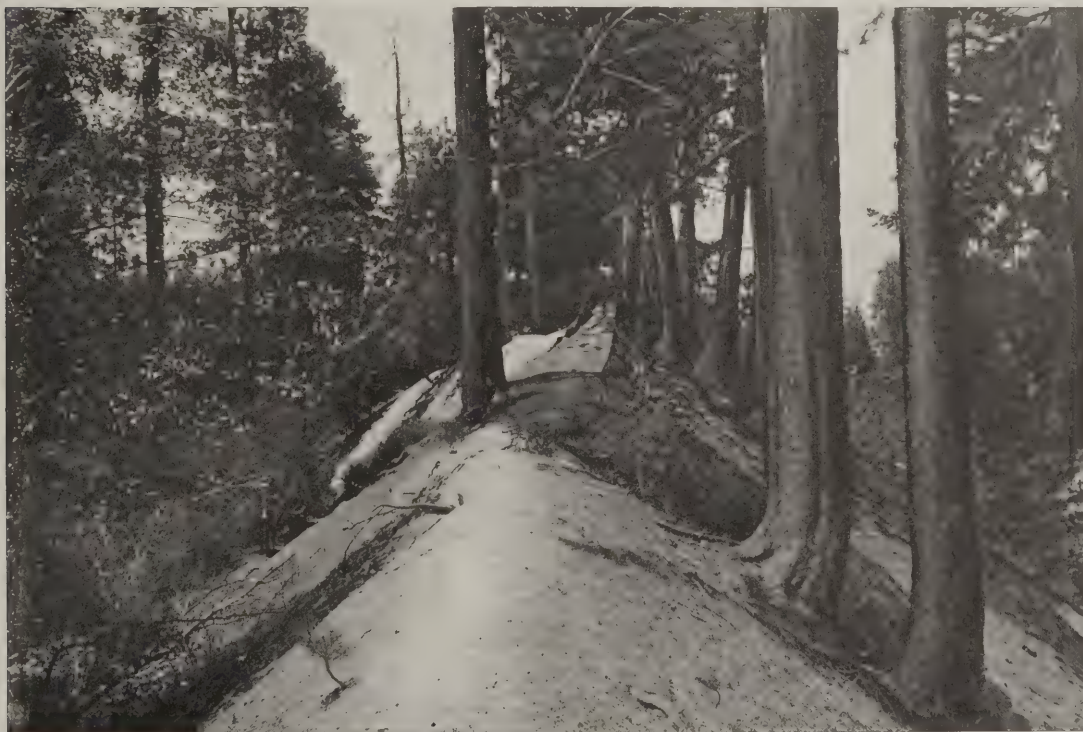
B. Ridge in the Rift near the head of Swartout Valley. H. W. F.

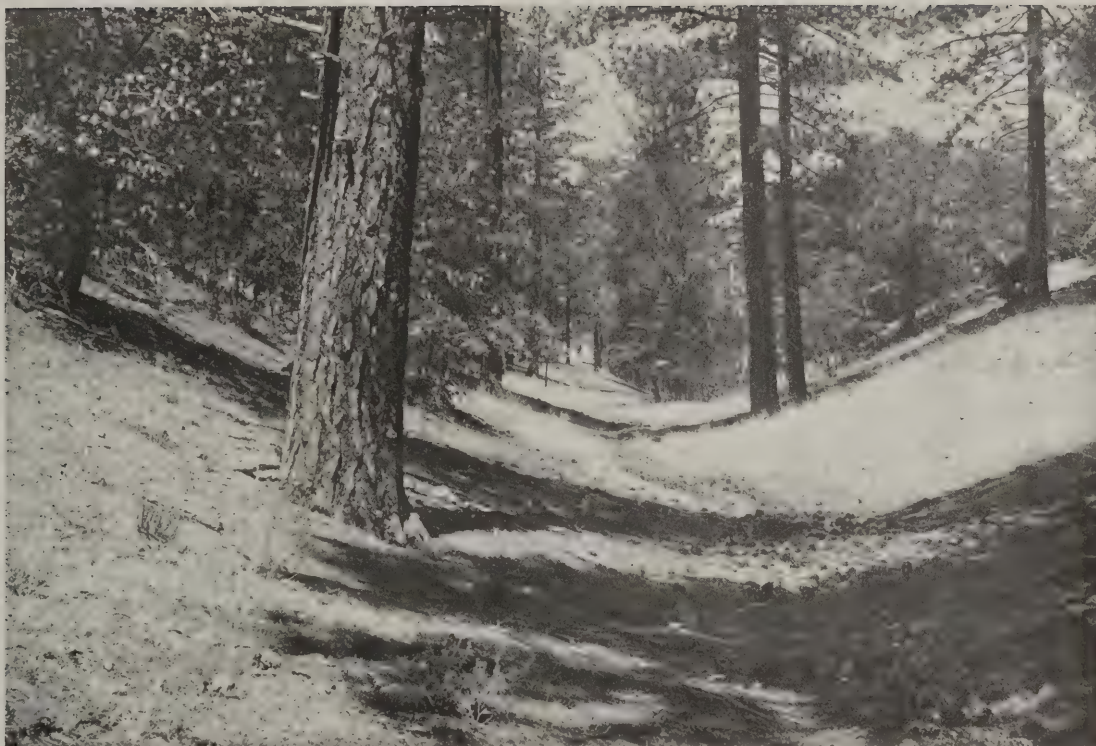
A. The Rift across the mountain crest west of Swartout Valley. North slope of San Gabriel Range. H. W. F.

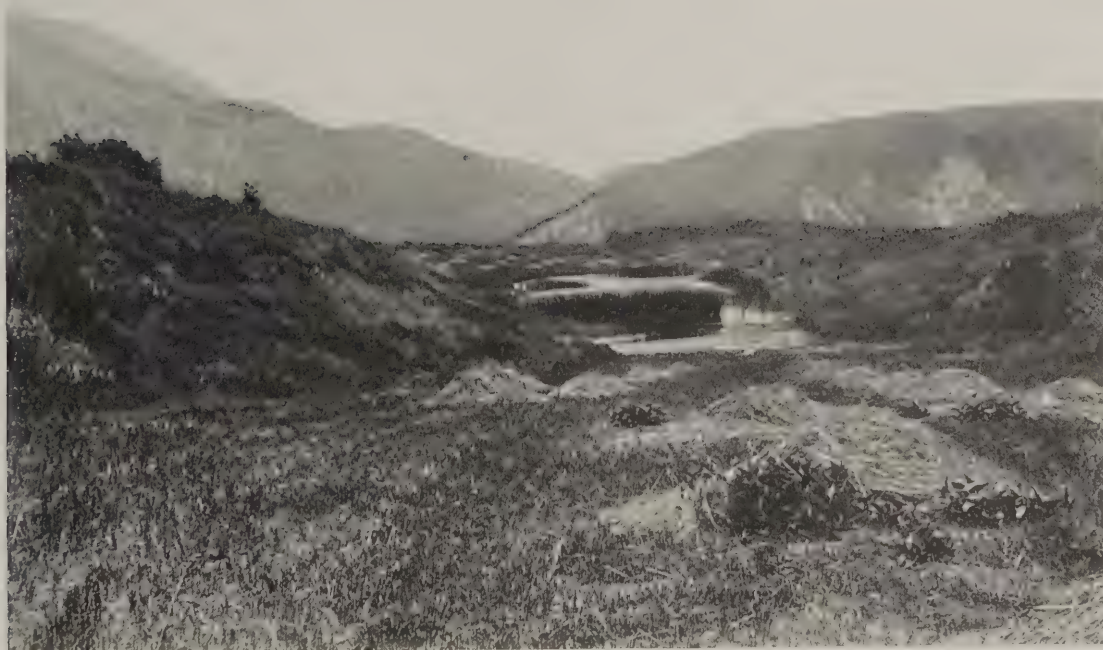
B. Looking southeast from lower end of Lone Pine Canyon across lower end of Cajon Canyon. Lake and meadow due to ridge in Rift. H. W. F.

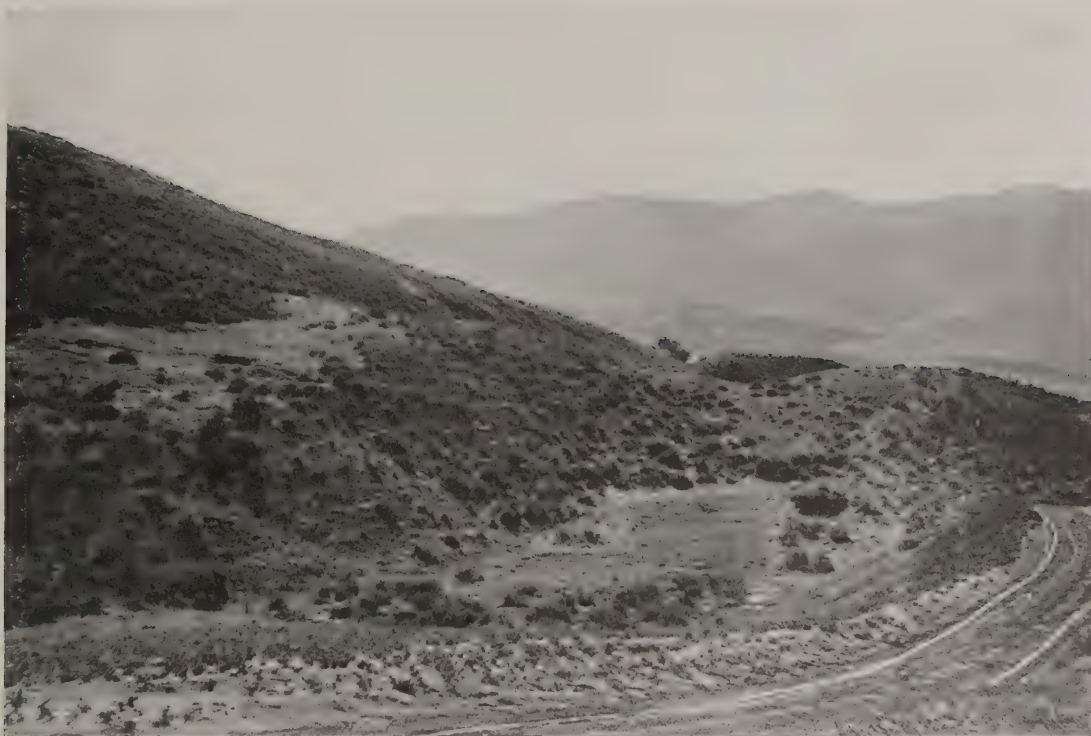
A. Looking west along the Rift from Cajon Pass, showing double scarp. H. W. F.

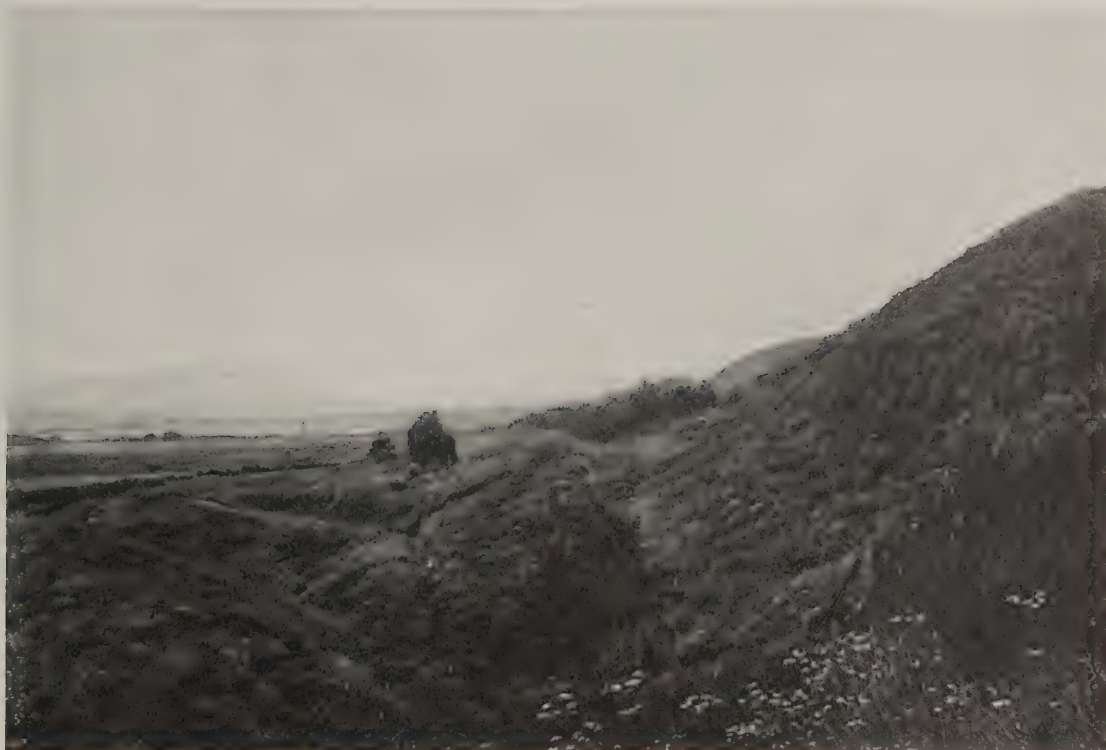
B. Double fault-scarp in Rift north of Highland, at base of San Bernardino Range. H. W. F.

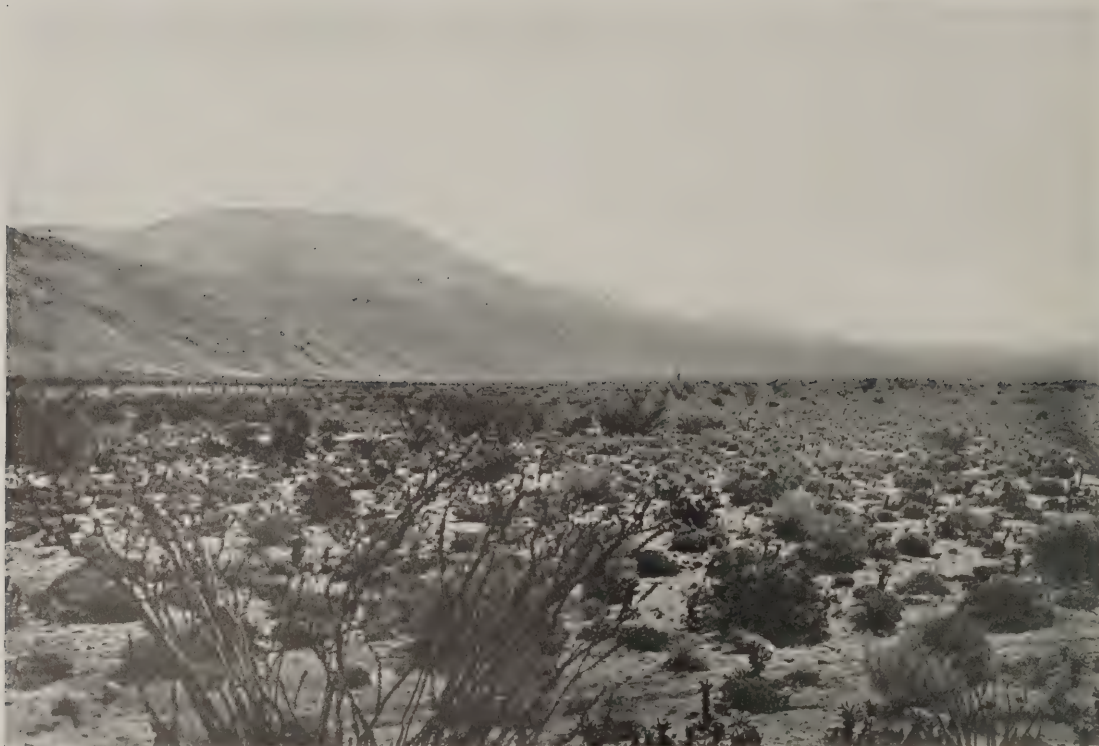
A. Looking east across Borego Valley toward south end of San Jacinto fault-scarp. H. W. F.

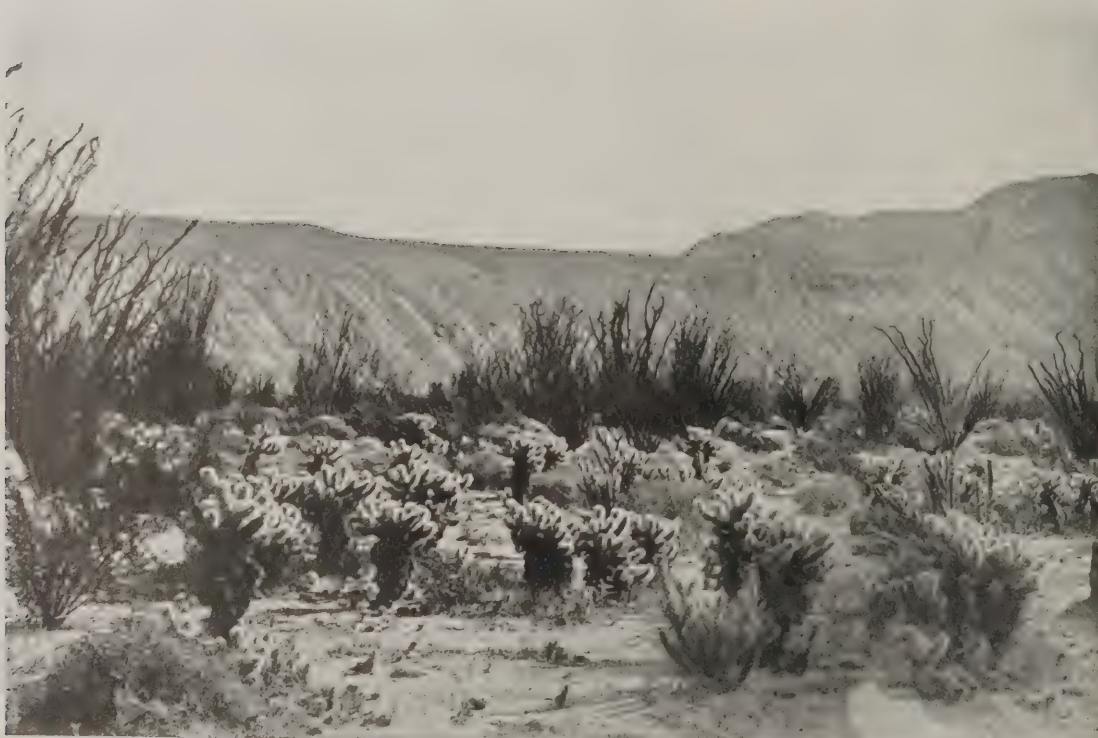
B. A nearer view of the San Jacinto fault-scarp, Upper end of Borego Valley, H. W. F.

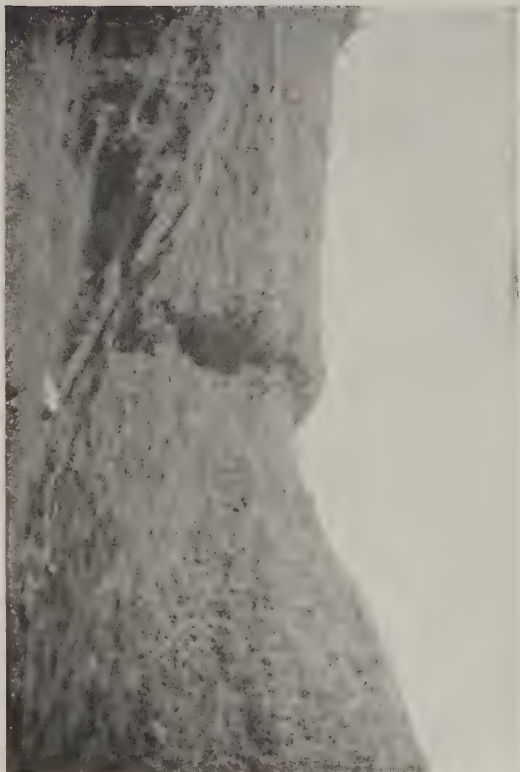
characteristic little gap or saddle (plate 31A), and south of *B* follows closely an old fault line, with a slight upthrow on the west. North of the road the fault-trace follows a ravine for some distance, then passes along the west side of a low ridge, as indicated in the contouring, and finally drops down to Humboldt Creek. Thence it ascends the

A. Fault-scarp passing thru saddle at head of Wood Gulch, looking south-southeast.
F. E. M.

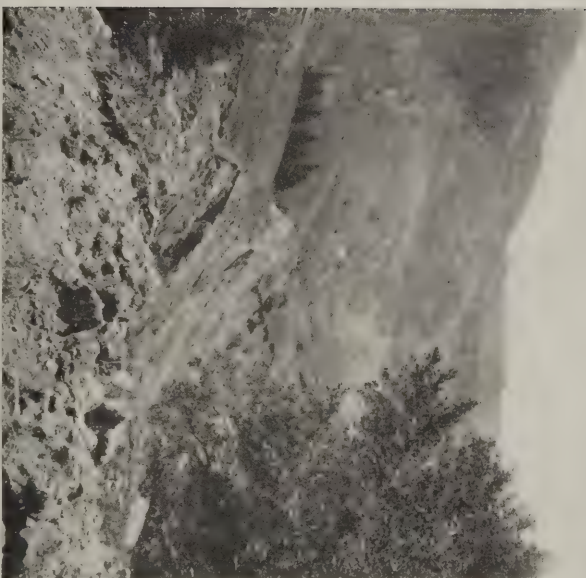
south slope of Telegraph Hill, following for a considerable distance a characteristic fault feature on the steep brushy spurs indicated in plate 31b. Immediately south of the summit of Telegraph Hill the disturbance is the most pronounced, being accompanied apparently by an upthrow on the west side, resulting in a sharp-crested ridge some 4 feet high. It is possible, however, that this ridge is not the result of the recent disturbance, but of a former one, modified into a more acute form by the shaking off of the sod. (See plate 31c.) From the summit of Telegraph Hill a bearing was taken over the entire length of the line down to Shelter Cove: N. 25° W. Projecting the line north from the hill on the azimuth, it appears to head for a number of high mountains of the King's Peak Range, altho no visible traces of the disturbance are found north of Telegraph Hill. Immediately north of its crest is the upper end of a great hopper-like landslide, clean swept for over a thousand feet. The fault-trace is entirely obliterated by this slide. The exact location of the fault north of Telegraph Hill was not ascertained. Under the

C. Looking south-southeast from Telegraph Hill along fault-trace marked by sharp-crested ridge in foreground, with upthrow of $4 \pm$ feet. F. E. M.

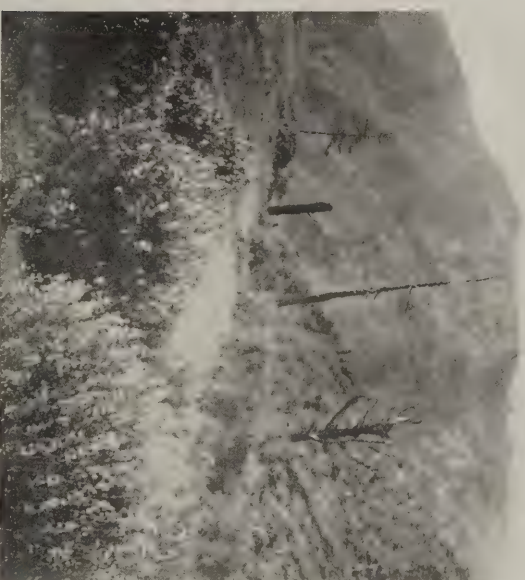
D. Looking north-northwest along main fault marked by small ridges on spurs of Telegraph Hill. F. E. M.

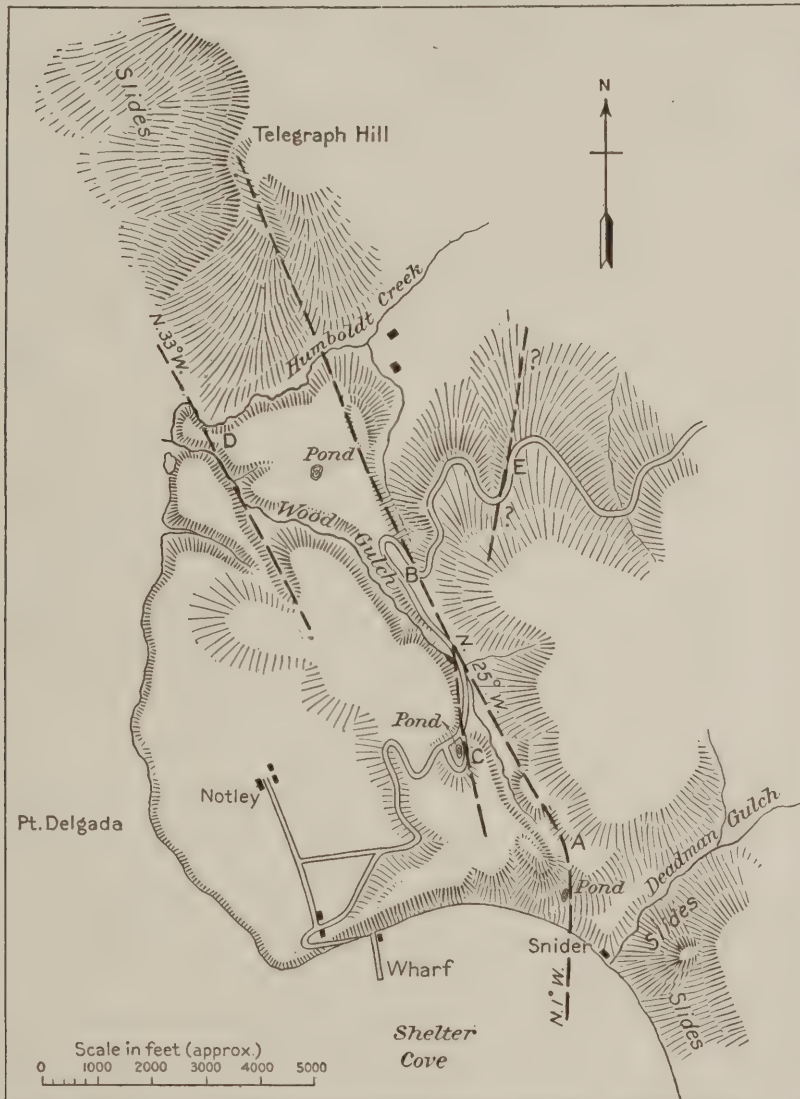
Of the auxiliary cracks, the first one, *C* (see fig. 11), is a less pronounced disturbance than the main fault-trace, passing thru a depression bordered on its east side by a low scarp due to former faulting. A small pond encircled by the road lies on this fault-trace. Its bearing (not measured) is such as to make the line converge toward the main fault-trace and intersect the same in the vicinity of the pond in the bottom of Wood Gulch. The horizontal displacement along this line is probably small, much like that on the

auxiliary fault cracks accompanying the main fault-trace in Sonoma and Mendocino Counties, which it greatly resembles in surface characteristics. Another line of some prominence was discovered near the mouths of Humboldt Creek and Wood Gulch. As fig. 11 indicates, this fault-trace, *D*, follows for some distance along Wood Gulch, then crosses over to the little gorge of Humboldt Creek (plate 31B), which it follows out to its mouth. The divide at *D* has a marked depression along the line of faulting. The fence cross-

FIG. 11.—Map of country north of Shelter Cove, Humboldt County, showing auxiliary faults in relation to main fault.

ing it shows no signs of horizontal shifting. It was not learned whether or not it has been repaired since the quake. Tracing it to the south up over the grassy hills, it is found to disappear somewhere near the head of the little gulch shown on the map. A third line was found along the wagon road at *E*, following an old fault ridge descending the hillside on a slant. Its probable connection with the *C* line suggests itself.

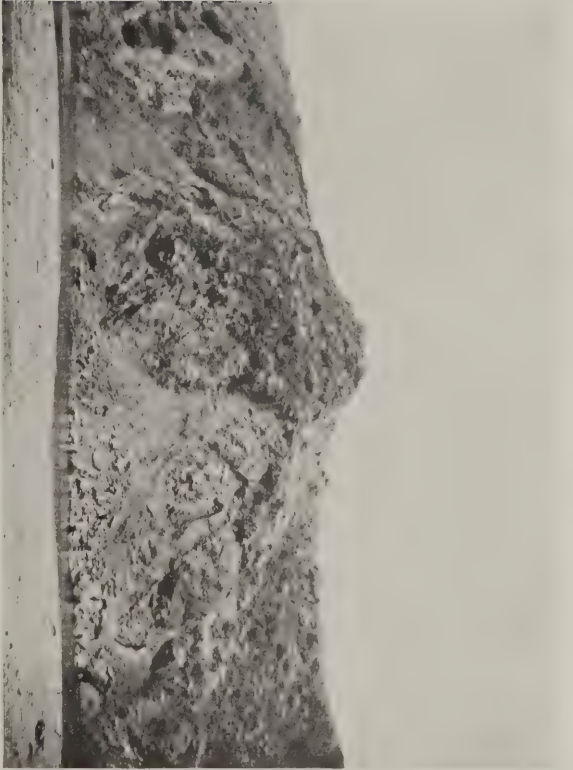
A. Rocky stream cliff 50 feet high on north side of Alder Creek. Fault vertical on left of knoll; auxiliary fault on right of knoll. F. E. M.

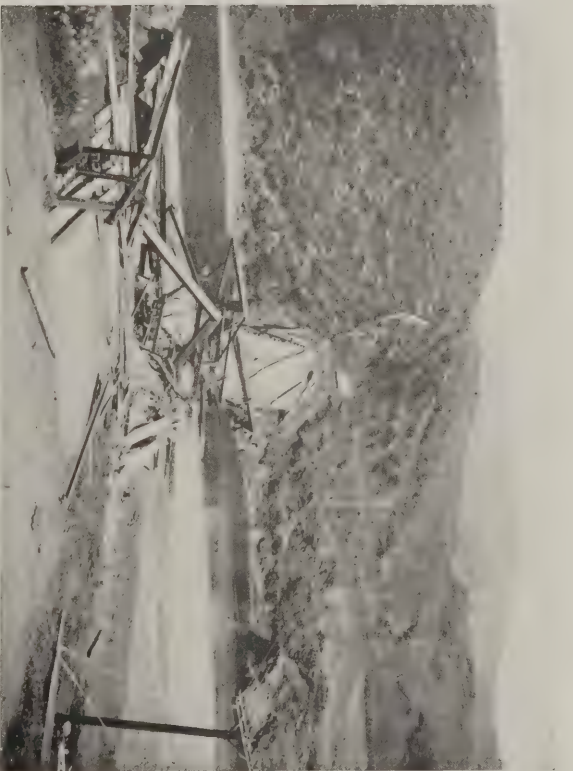
Southeast of this point, the fault-trace follows the broad stream bed of Alder Creek for nearly a mile, passing beneath a bridge, the wreck of which is shown in plate 32B. In this view, the horizontal offset of the bridge along the fault-line is well shown. It is apparent that this offset is not less than the width of the bridge. On the southwest side of the stream, near the bridge (A, fig. 12), the fault-trace is flanked by peculiar, isolated, rocky knobs similar to that on the northeast side. It is not clear, however, that these rocky knobs have more than an accidental relation to the fault, since they may possibly be residual sea-stacks upon the uplifted wave-cut terrace.

B. Fault passing under bridge over Alder Creek. Bridge displaced not less than its width. F. E. M.

The wagon bridge over Alder Creek (plate 32B), which stood astride of the fault, is a complete wreck. The timbers broke in many places, and the tension rods were twisted and in some cases actually ruptured.

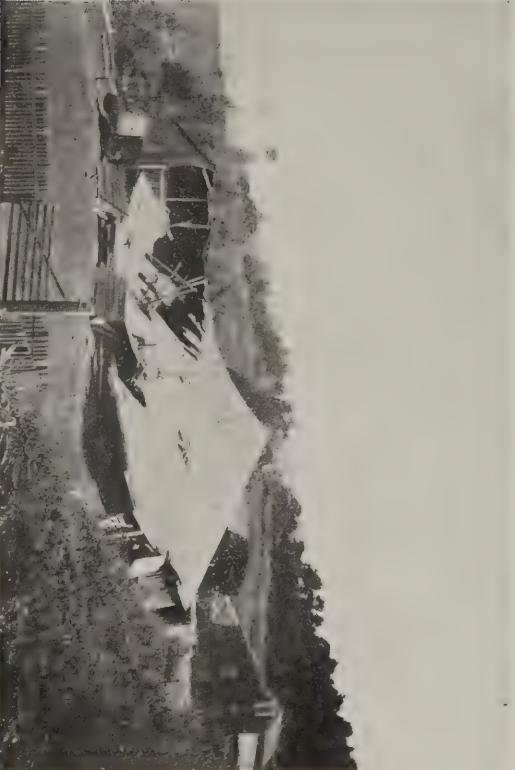
C. Barn of E. E. Fitch, north of Manchester. Astride the fault. F. E. M.

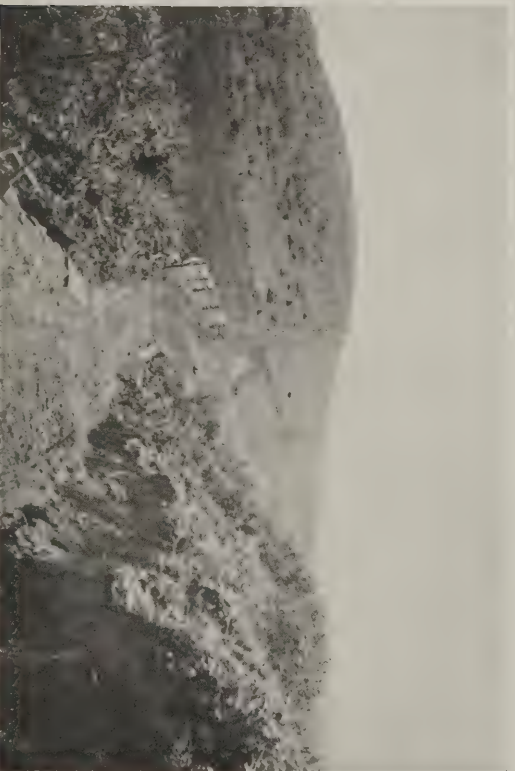
the zone of dislocation being in low, marshy ground. At another place near Manchester, where an east and west fence follows the north side of a wagon road, both fence and road have been offset as shown in plate 32b. In both cases the relative movement on the southwest side was to the northwest. The dairy barn on the ranch of Mr. E. E. Fitch stood astride the line of movement and was demolished by the torsion to which it was subjected. The wreck of the barn is shown in plate 32c. At two places along the stretch between Alder and Brush Creeks the bearing of the fault-trace was measured, the readings being N. 28° W. and N. 30° W.

D. East-west fence 0.25 mile north of Manchester offset by fault. Fence and road were formerly straight and have been repaired. Looking east. F. E. M.

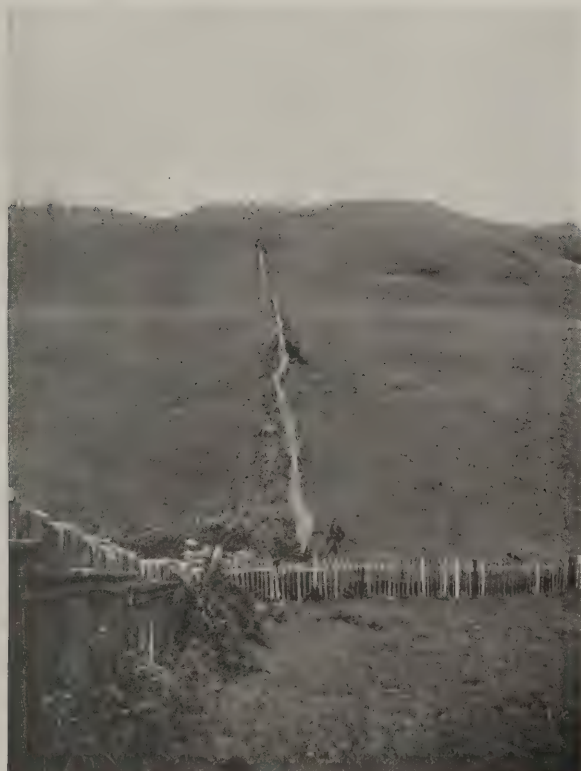
A. East-west fence near saddle between Garcia River and Brush Creek. Main offset 13 feet. Auxiliary offset 2.5 feet in middle ground. F. E. M.

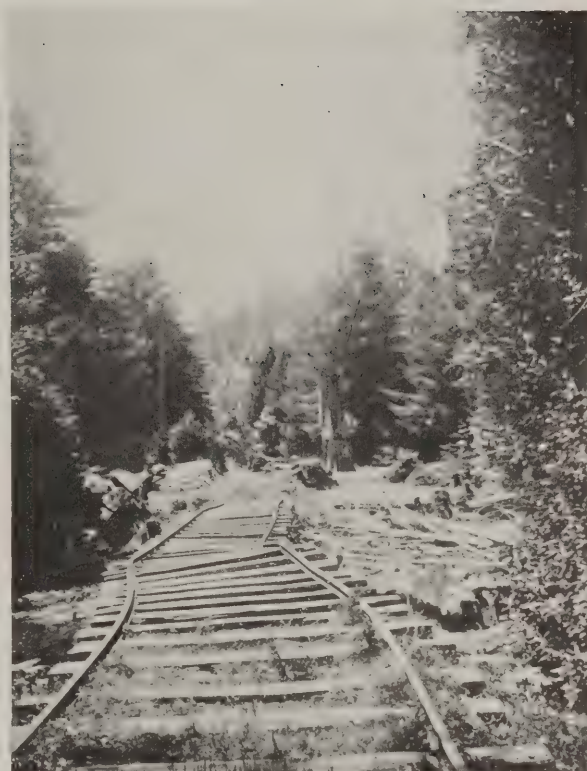
B. Small railway trestle, Little North Fork Gualala River, looking north. Main fault-trace 100 feet to right. Auxiliary crack under trestle. F. E. M.
